Manhole Inspection Summary

Manhole # S17KK_002MH

Insp Date: **6/7/07 9:51 AM**

Location Address: **2047 RUXTON AVE**

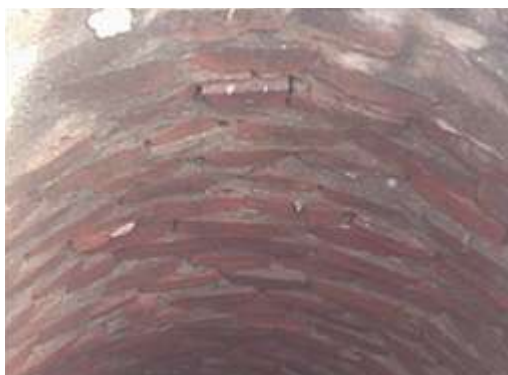
Defect 1

Condition: ☐ Sound ☐ Cracked ☐ Root Intrusion ☒ **Loose Brick** ☐ Deteriorated

LOOSE CORBEL BRICKS

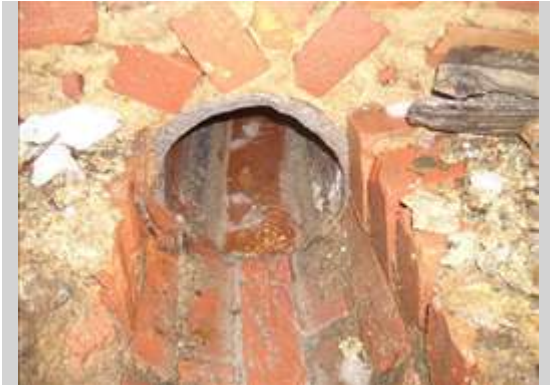
8 in. Circular Gravity Sewer
Pipe Out @ 12 O'Clock

Pipe Height: **8.4** (in.) Rod and Bar (Angled)
Pipe Material: **Clay** ☐ Pipe Lined
Invert Depth: **12.44** (ft.) Flow Characteristics: **Slow**
Deposits: ☐ None ☒ **Mud** ☐ Sludge ☐ Debris ☐ Grease
Silt Depth: **2** (in.) Deposits Extent: **Light**
Infiltration: **None** Pipe Seal Cond: **Sound**

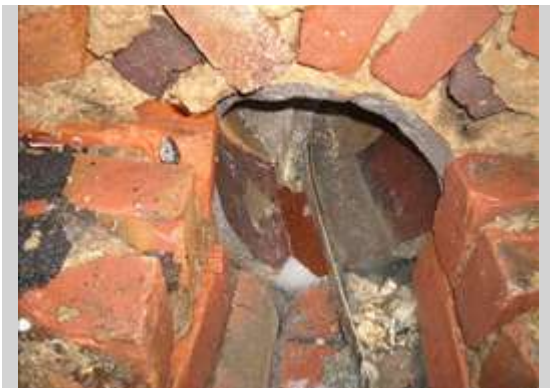
8 in. Circular Gravity Sewer
Pipe In @ 3 O'Clock

Pipe Height: **8.4** (in.) Rod and Bar (Angled)
Pipe Material: **Clay** ☐ Pipe Lined
Invert Depth: **12.11** (ft.) Flow Characteristics: **Slow**
Deposits: ☒ **None** ☐ Mud ☐ Sludge ☐ Debris ☐ Grease
Silt Depth: (in.) Deposits Extent:
Infiltration: **None** Pipe Seal Cond: **Sound**

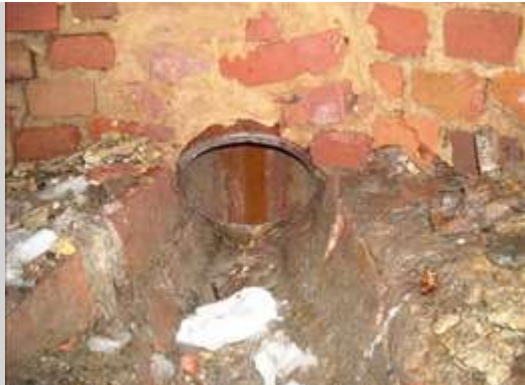
Drop In @ 8 O'Clock

Deposits: ☐ None ☐ Mud ☐ Sludge ☐ Debris ☒ **Grease**

Silt Depth: **8** (in.) Deposits Extent: **Heavy**

Drop Condition: **Partly Clogged**
